Earthquake Resistant Design and Rehabilitation of Masonry Historical Structures

Abstract: A general methodology for the earthquake resistant design and rehabilitation of damaged masonry historical structures is presented. The whole process is illustrated through a case study: The rehabilitation of Zoodohos Pigi Holy Temple in Athens; a structure that suffered extensive damage during the September 1999 Athens earthquake. The procedures followed in the design, together with a description of the actions taken for the rehabilitation of the Temple and its strengthening against future earthquake actions, are reported.

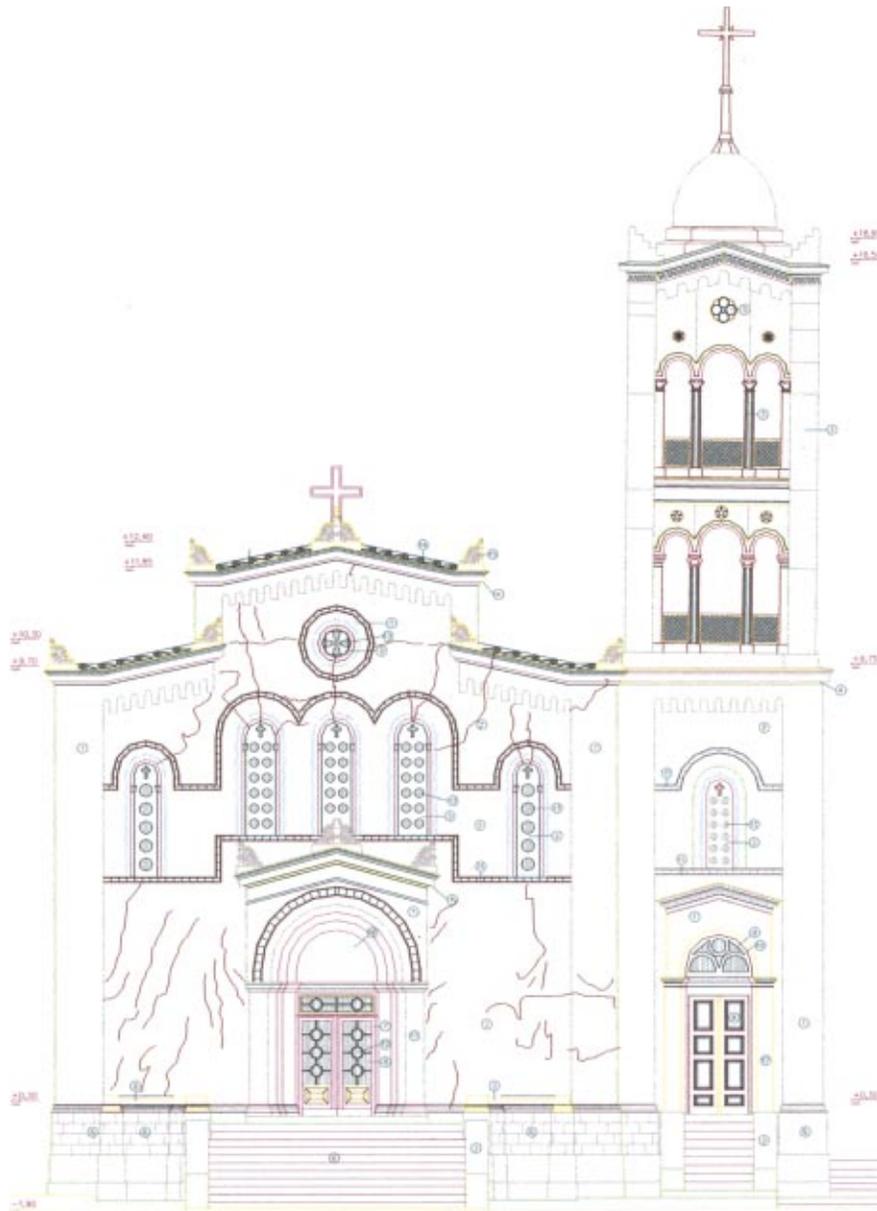
Fig. 1. (Color) Main façade of the church (western view)

The above methodology is illustrated here in a comprehensive form, through the case study of rehabilitation of the Zoodohos Pigi Holy Temple in Athens (Fig. 1); a structure that has suffered extensive damage during the September 1999 Athens earthquake.

cross vaults appear. Extensive cracks can also be observed at the brick arch openings of the north and west side perimeter masonry walls of the structure. The crack pattern formation on the main façade of the Temple has been depicted in Fig. 1. The lack of maintenance of the roof, in conjunction to the absence of insulation and protection against humidity, results in the wearing out of the vaulted structure, making it more vulnerable to future seismic activity. The very good seismic behavior of the belfry, however, has to be noticed.

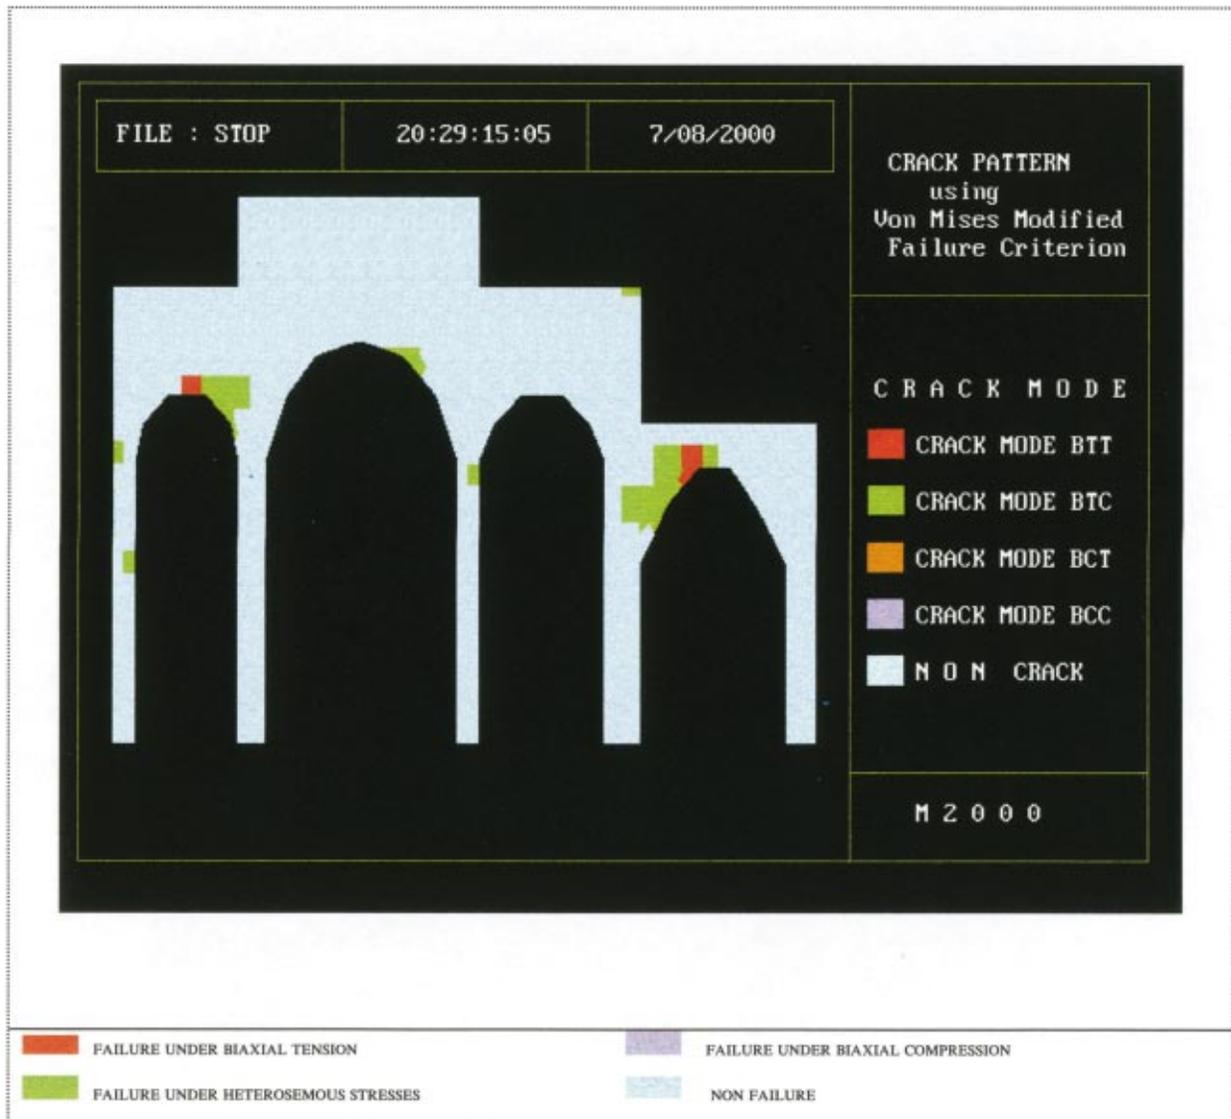
Fig. 5. (Color) Failure results of internal wall, before interventions

Step 6: Failure criterion. A masonry failure criterion under biaxial stress state recently proposed (Asteris 2000; Syrmakizis and Asteris 2001), has been used (Fig. 4), in order to determine the failed regions of the structure. In addition to the main computer program used for the analysis (*SAP2000*), a special computer program, capable of producing a “visual” representation of the failed regions within the structure, has been developed. The program gives statistics for the number of failure points, as well as of the type of failure, providing a general view of the probable damage level and the main type of damages within the structure. As an example, the failed points of the internal wall of the temple are depicted on Fig. 5. These diagrams have been proven very useful for the extraction of the required conclusions about the general type of failures in the structure, as well as for decision making concerning the type and the extent of interventions. It can be concluded from Fig. 5 that the particular wall has failed mainly under biaxial tension compression.

For the reapplication of the failure criterion of Step 6, in order to define the failed regions of the rehabilitated structure, the new analysis results produced in Step 8, are used. The new failed regions, after the rehabilitation of the internal wall of the temple, are presented in Fig. 6, and these are directly compared to the failure results of Fig. 5.
