Structural analysis methodology for historical buildings

C.A. Syrmakezis, M.P. Chronopoulos, A.A. Sophocleous,
P.G. Asteris

*National Technical University of Athens, Zografou Campus,
GR-15773, Athens, Greece*

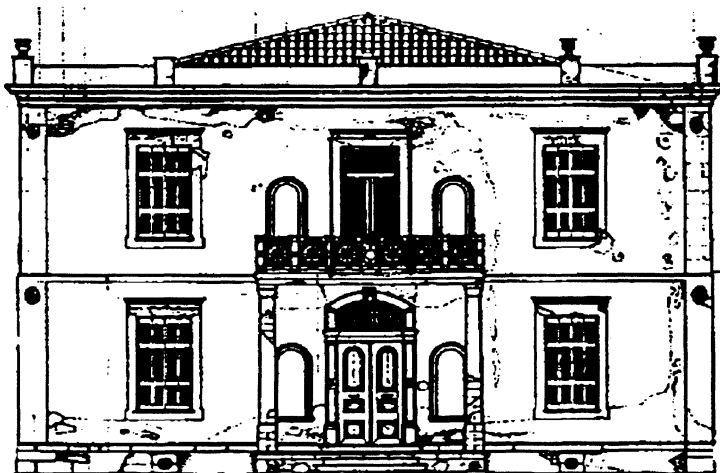
Fig. 1 The front facade of the building (drawing by Architect Mrs A. Violaki).

The present paper describes a methodology for the structural analysis process of historical damaged buildings either before, or after their repair and/or strengthening. The paper is presented as a final output of a research project undertaken by the authors in the Institute of Structural Analysis and Aseismic Research of NTUA, in the period 1992-94, entitled "Rehabilitation of Historical Buildings in Crete". The project was aiming to present a complete methodology for the structural analysis of such buildings, and apply it in two real examples, two historical buildings in the cities of Chania and Sitia. In the paper the methodology proposed is illustrated using the case study of one of the buildings (in Chania), a 3-story (2 floors + basement) masonry building with wooden horizontal diaphragms (floors, roof), of about 15x15 m plan dimensions. On Fig.1 the front facade of the building is depicted.

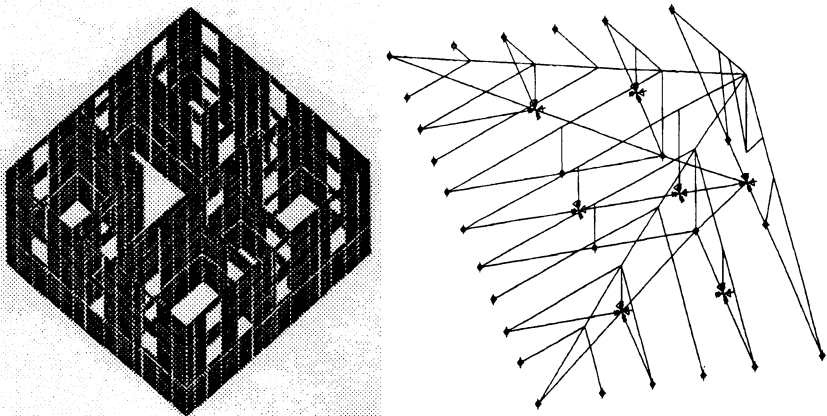
Fig. 3 The 3-D FEM model of the building and the roof.

2. For the simulation of the structural characteristics, a 3-D finite element model consisting of 2788 joints, 2216 shell elements and 3 frame elements has been created. For the simulation of the wooden roof of the building (half part) a 3-D truss model has been created, using 57 joints and 82 elements (Fig. 3).

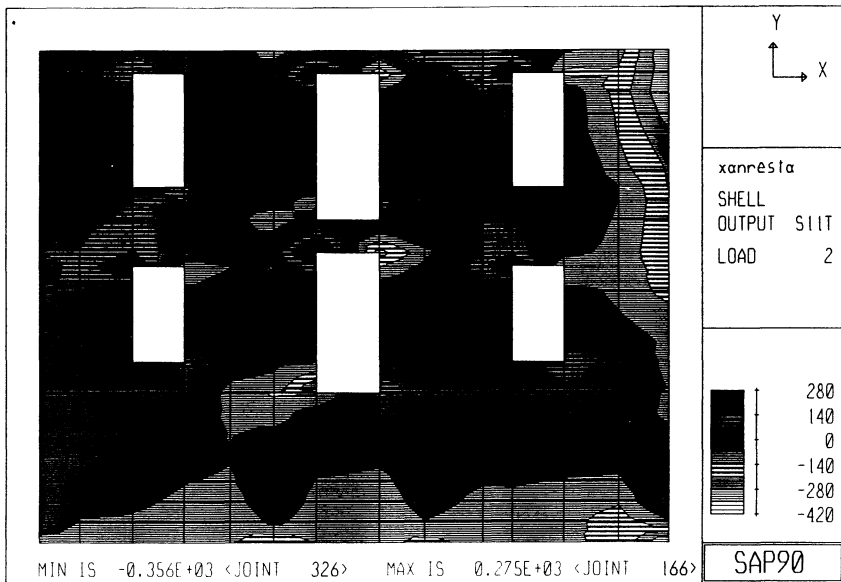
Fig. 6. Typical graphical output of the analysis results after interventions.

On Fig.6 a graphical output of the analysis after the proposed interventions is depicted. Comparison of Figures 4 and 6 shows the significant decrease of the stress level.
